Waverly Point Farmhouse
CH-739
Newburg
Private

Circa 1885

Maryland Inventory of Historic Properties Form

Inventory No. CH-739

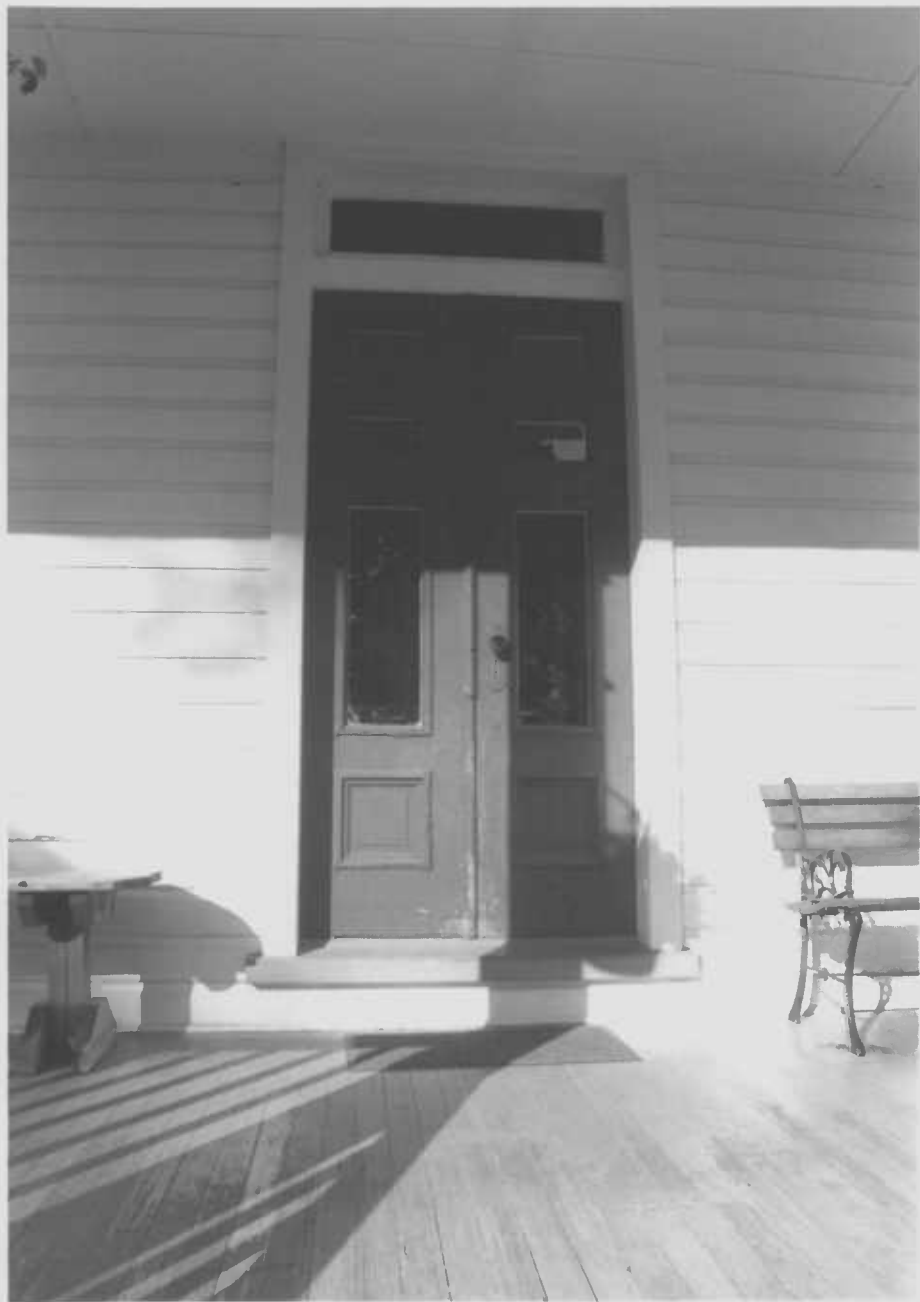
2 of 8

The roof is covered with asphalt shingles and is pierced with three interior brick chimneys with corbelled caps. The cornice is boxed. The front elevation is three bays in width with the center bay projecting outward and capped with a cross-gable. This gable holds a round louvered vent. The hipped roof porch rests on six square wooden posts. A porch railing surrounds the 2 1/2" tongue and groove wood plank floor. The porch ceiling has been repaired using plywood. Windows on this elevation currently consist on 9/9 light double hung sash. The principal entrance include an original, yet altered front double door. The top three original raised wood panels have been fitted with glass window panes to allow more light into the foyer.

DOOR DETAIL

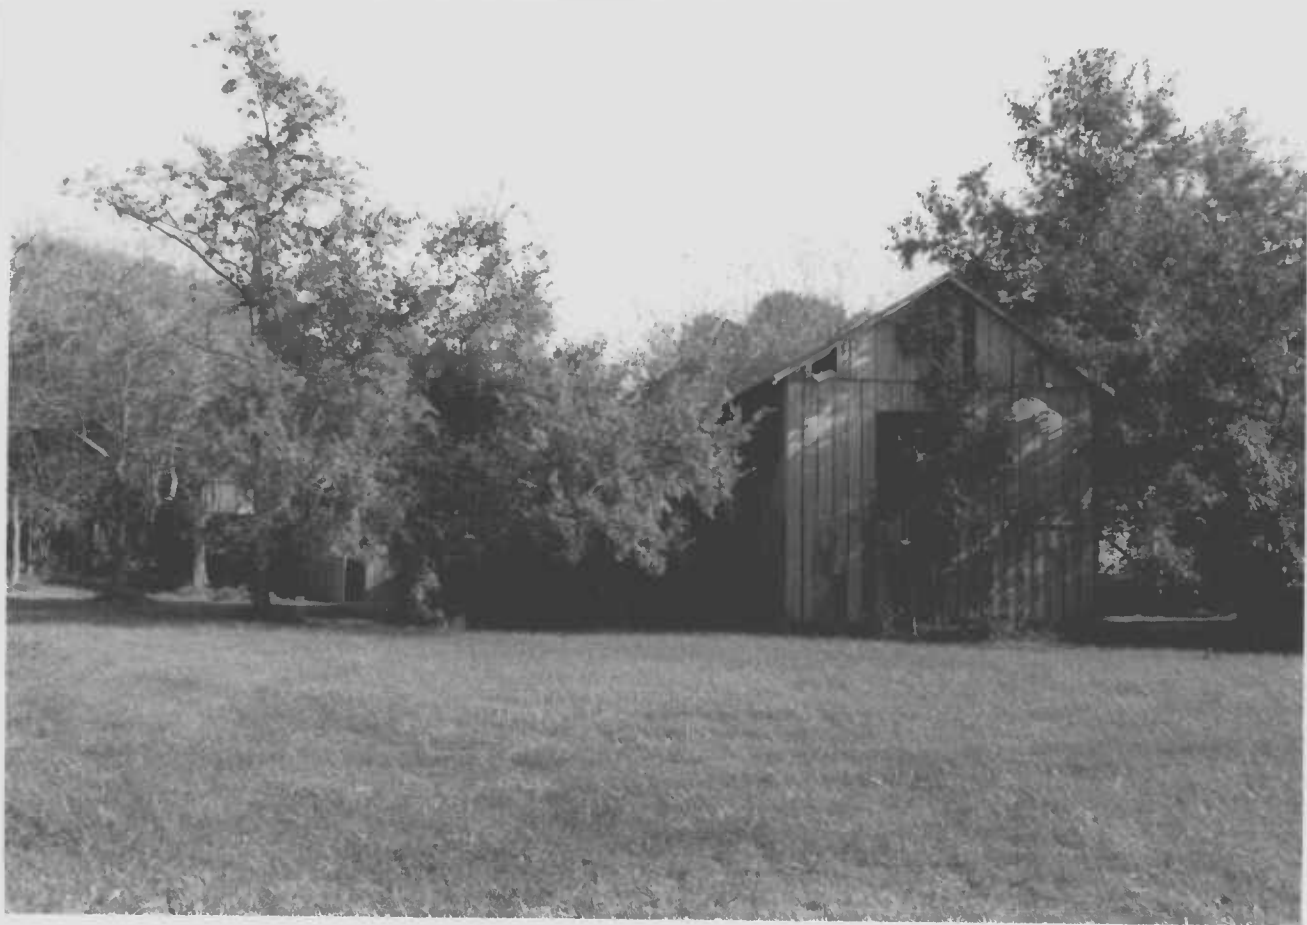
6 OF 8

The site includes a stable with loft above covered in vertical board siding and a metal roof on a north/south axis. To the west is a large cornhouse that has been converted into a cabin. To the north of the house is a garage with attached shed. This structure has a metal roof and is covered in weatherboard siding over diagonal nailors. The garage and stable are in poor condition.

STABLE LOOKINGS

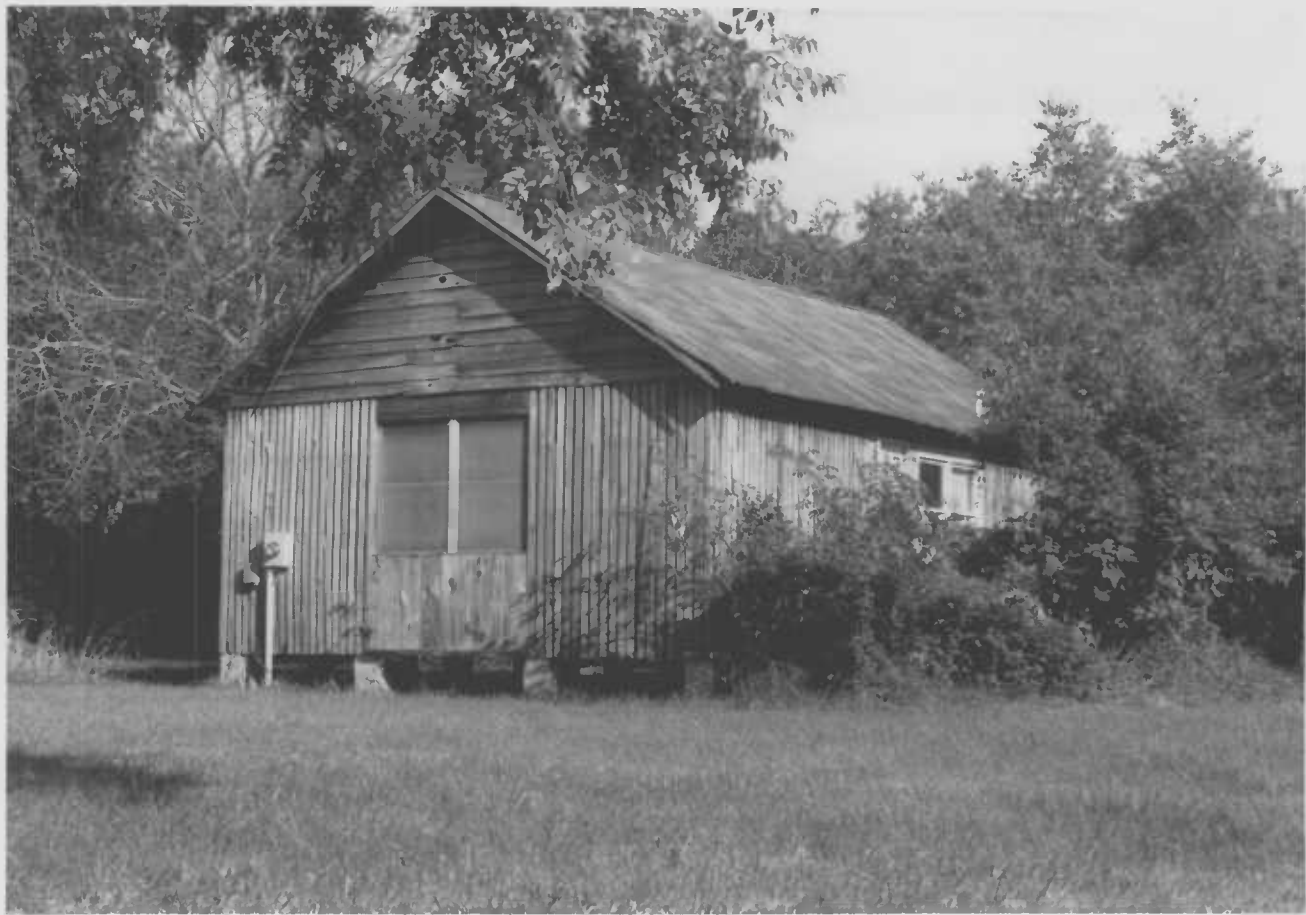
70F8

CORNHOUSE, LOOKING SW

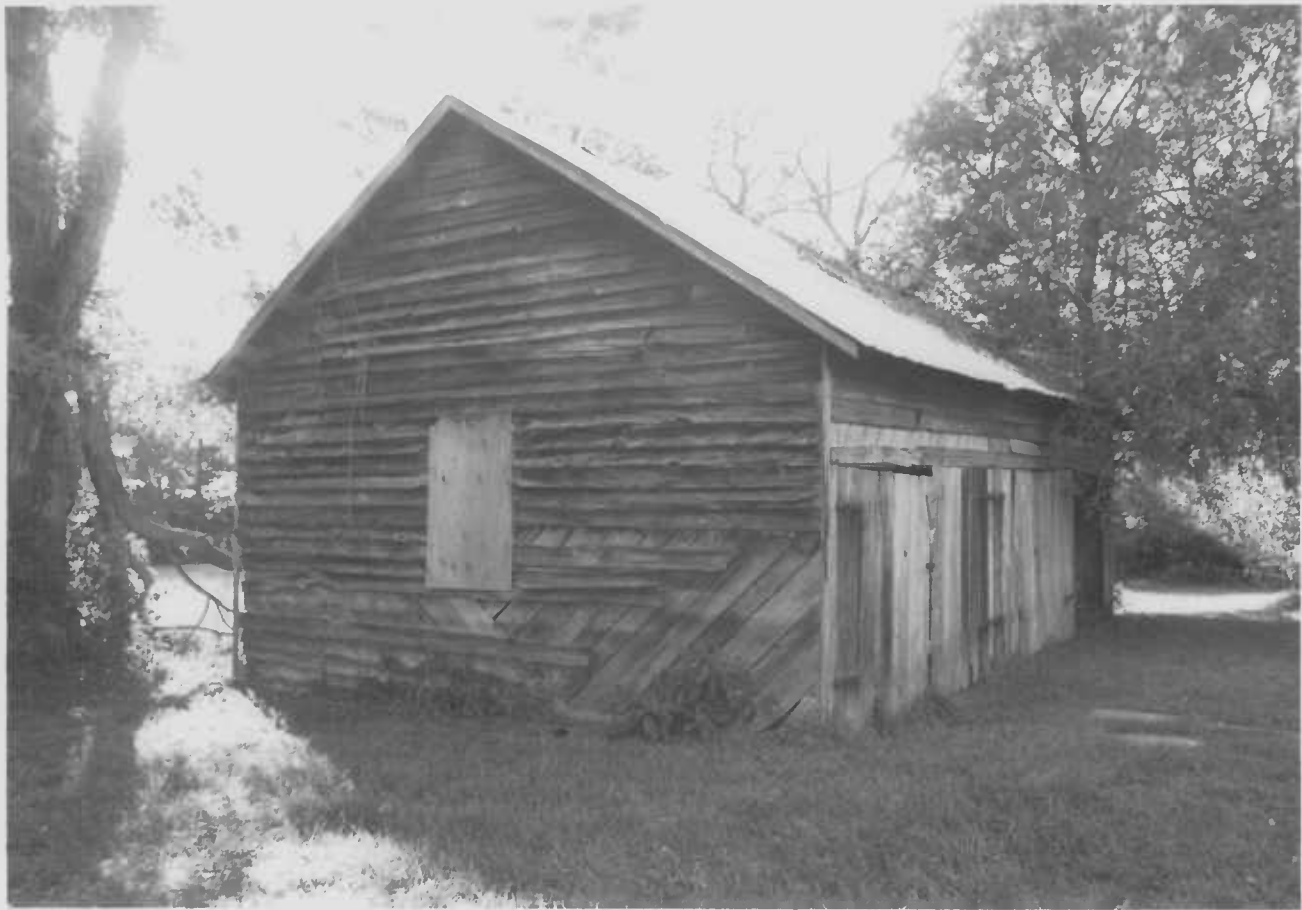
30PS

GARAGE, LOOKING NW
